Drywall Cracking and Crownning (DCC) Problems in Arid Environments**Grietas y coronas en los paneles de yeso (GCPY) Problemas en los ambientes áridos**

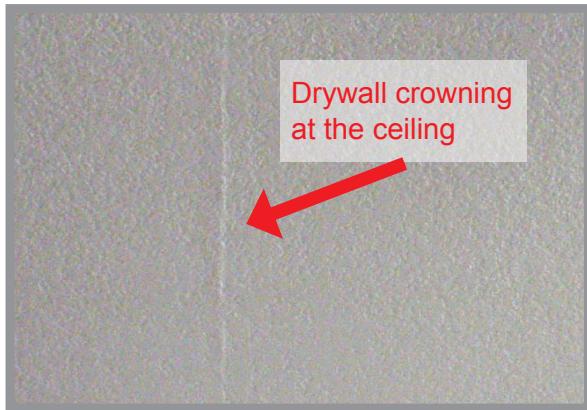
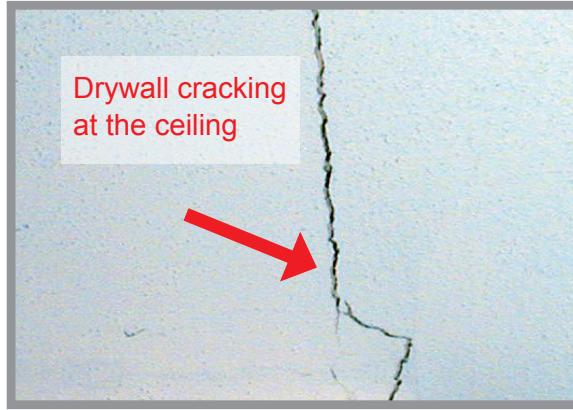
Cracks in drywall can occur for a variety of reasons including ground settlement, building movement, out-of-level bearing conditions, deflection of supporting members and partition separation (refer to the TTB Partition Separation for more information on this). One particular type of drywall cracking and crowning (DCC) occurs when gypsum board is pulled apart and forced together during alternating periods of dry and humid conditions.¹ Significant seasonal extremes in humidity occur primarily in the arid states of Arizona, Nevada, Colorado, Texas and California. These areas have reported higher incidences of DCC in finished structures. Similar cases of DCC have also been reported in the arid regions of Australia and New Zealand.

Lumber and drywall expand and contract with changes in humidity. However, calculations show lumber shrinkage/expansion caused by seasonal changes in humidity is insignificant and insufficient to cause DCC in typical construction. For example, in Las Vegas the equilibrium moisture content (EMC) of wood varies from 8.5% in January to 4.0% in June.² Under these conditions, the amount of longitudinal shrinkage between two wood fasteners spaced 12 inches apart would be 0.00325 inches, the thickness of a piece of paper.³

Lumber moisture content in finished structures is roughly 8% in arid parts of the country compared to 12% in the rest of the country.

Gypsum board must be thoroughly dry and at ambient temperature before application.⁴

The relative humidity within the structure must be controlled before, during and after gypsum board application.⁴

Drywall attachment must always proceed from the center of the panel to the ends and edges. Drywall must not be attached at the corners first and then left to hang prior to the field being attached.⁴

A control joint or intermediate blocking must be installed where framing members change direction.⁴

Control joints in interior ceilings without perimeter relief must be installed so that linear dimensions do not exceed 30 ft. and total area between control joints does not exceed 900 sq. ft.⁴
